MELTED STEEL: How Important?

by John J. Lentini, C.F.I.
J. Finis McCarver, P.E.

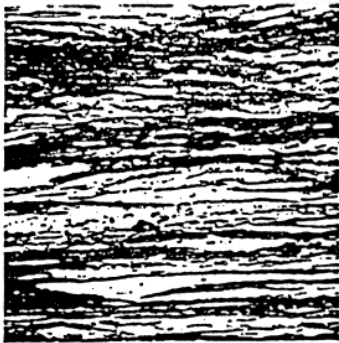
When exposed to a fire, steel bedsprings will undergo four distinct changes, as the temperature increases. Unfortunately, only the first two changes are likely to be detectable by visual observation. Figure 2 shows the microstructure of a bedspring before it has been heated. The radically elongated grains are typical of spring steel. Upon exposure to elevated temperatures (up to 1,300°F), the spring will anneal and lose most of its residual tension, as a result of stress relief, as shown in Figure 3.

Figure 2: Unheated Bedspring Material. The Metal Consists of Radically Elongated Grains of Pearlite (Dark) and Ferrite (Light) Grains. Nital Etch. 500X.

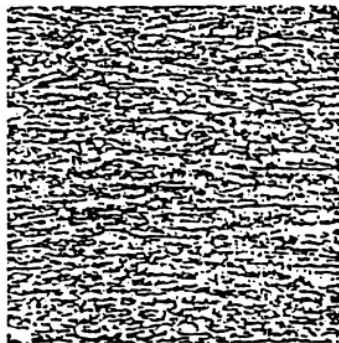
Figure 3: Bedspring Material Heated to 1,500°F for 2.5 Hours and Air Cooled. The Material Has Been Stressed Relieved, and Metallurgically Consists of Elongated Grains of Ferrite and Pearlite. Nital Etch. 500X.

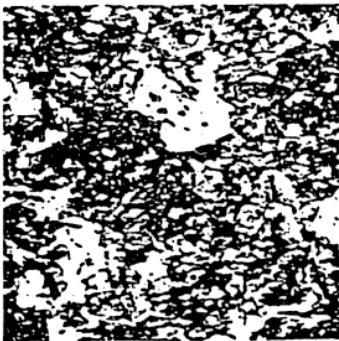
After exposure to temperatures over about 1,300°F, the grains of steel actually recrystallize, and the microstructure shown in Figure 4 is typical. A heavy oxidation scale will usually be present on steel which has been exposed to temperatures sufficiently high to cause recrystallization.

Figure 4: Bedspring Material Heated to 1,500°F for 2.5 Hours and Air Cooled. The Material Now Consists of Recrystallized Grains of Ferrite and Pearlite. Note that the Grains Are No Longer Elongated. Nital Etch. 500X.

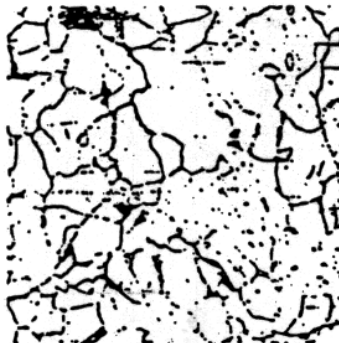
At even higher temperatures, decarburization (loss of carbon) of the steel occurs, and the microstructure shown in Figure 5 may be expected. This microstructure was obtained after heating at 1,800°F for two and one half hours.

Figure 5: Bedspring Material Heated to 1,800°F for 2.5 Hours and Air Cooled. Because of Decarburization, the Material Now Consists Entirely of Recrystallized Ferrite Grains. Nital Etch. 500X.
